# Army Lodging Wellness Recommendation

## Fort Hood - Final Submittal

August 4, 2003

# Section 1 Wellness Recommendation

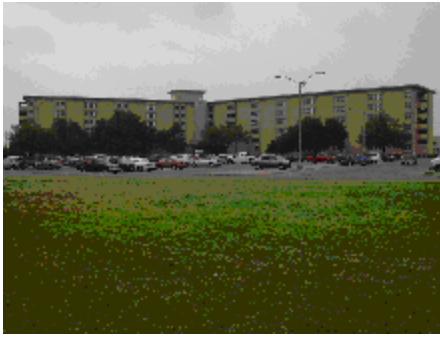
*Building 36006  
36006 Wratten Drive*

Building 36006, Keith Ware Hall, is located near the main entry gate and serves as the primary Lodging office for the installation. Built in 1968, and having recently gone through a 5 million dollar renovation, this facility is in excellent condition. The facility currently houses 208 single units with kitchenettes which meet current lodging standards, and 62 family suites which exceed lodging standard square footage requirements. In addition, there are four 4 room suites in the north wing which far exceed Army Lodging amenity and square footage standards. **The existing public and back-of-house spaces do not meet Army Lodging standards, and do not include in-house-laundry capabilities.**

Our recommendation for this facility is to convert the four 4-bedroom suites into additional back-of-the-house spaces and public spaces, and revert existing administrative and back-of the house spaces back to 3 guest rooms. Converting the 62 existing family suites to lodging standards would provide minimal benefit at considerable cost. Therefore, it is recommended that these rooms remain as they are.
